Coating Problems (Machine)

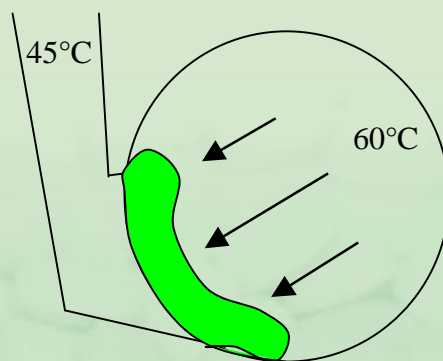
All air within the process path should pass via the tablet bed (Fig A) heating and efficiently drying the tablets in process, any air missing the tablet bed is effectively a loss.

Good Seal
Fig A

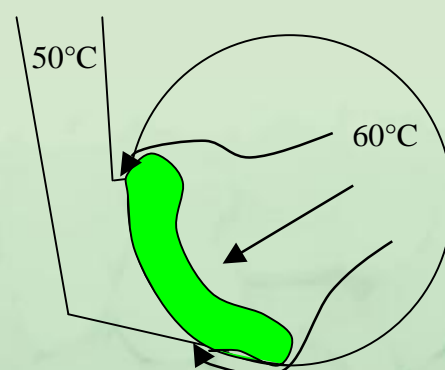
The problem is air will take the easiest path and if seals are damaged or worn the air can skip around the tablet bed reducing the drying efficiency (Fig B).

The reduction in drying air will extend the process time or can give an inaccurate indication of tablet bed temperature.

Indicating the exhaust air at a higher temperature than the actual tablet bed giving the possibility of over wetting.

Additionally if air is allowed to avoid the tablet bed by leaking in to the plenum due to faulty seals the air path is disturbed and can give rise to the spray path being erratic allowing the spray pattern to spray parts of the machine it should not this can also increase spray drying and additional product loss.

Damaged Seal
Fig B

Plenum seals are the only regular maintenance within a machine and should be checked at least once a year. Often the access to the seal is in a service area and the operator is unaware of the need to check or the impact on process.
